REPORT NO. 3555

THE PENNSYLVANIA RAILROAD COMPANY

IN RE ACCIDENT

AT BROADWAY STATION,

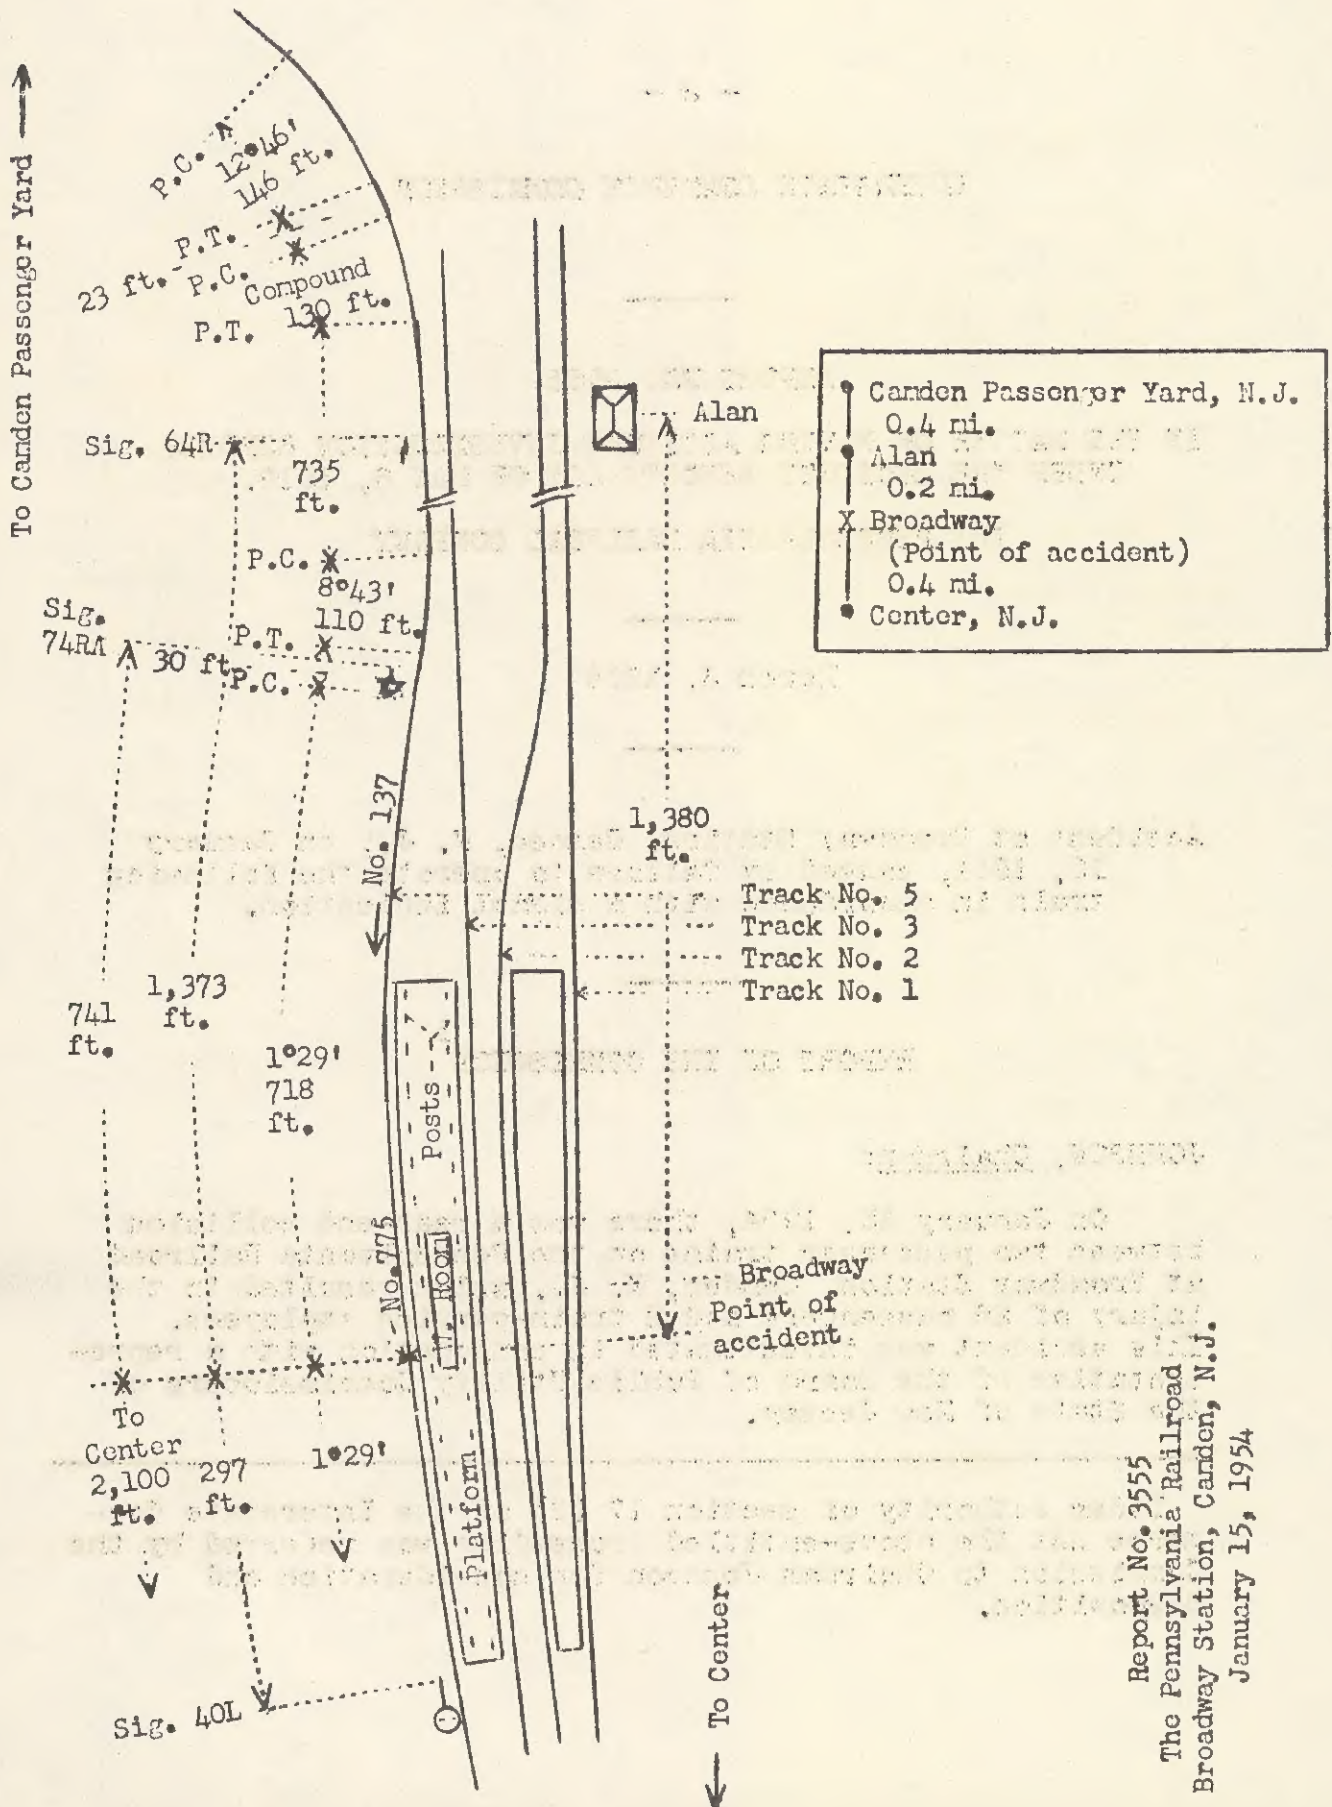
Report No. 3555
The Pennsylvania Railroad
Broadway Station, Camden, N.J.
January 15, 1954

Semi-automatic signals 64R, 74Ra, and 40L governing south-bound movements on track No. 5, are located, respectively, 1,373 feet north, 741 feet north, and 297 feet south of the point of accident. Signals 64R and 74Ra are of the dwarf position-light type and each displays four aspects. They are continuously lighted. Aspects applicable to this investigation and the corresponding indications and names are as follows:

The controlling circuits are so arranged that when the route is lined for a south-bound movement on track No. 5 and the block of signal 74Ra is occupied, signal 64R indicates Slow-approach and signal 74Ra indicates Restricting.
